The Preservation and Repair of Historic Stucco

Anne Grimmer

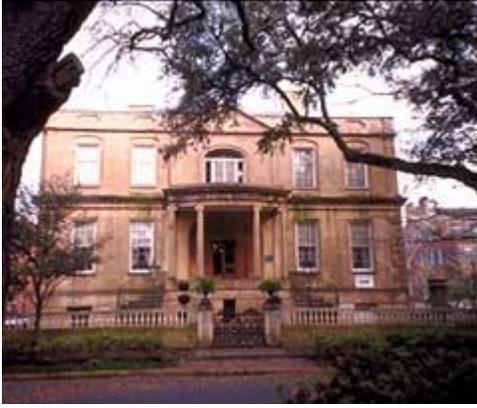
The stucco on the early-19th century Richardson-Owens-Thomas House in Savannah, Georgia, is a type of natural cement. Photo: NPS files.

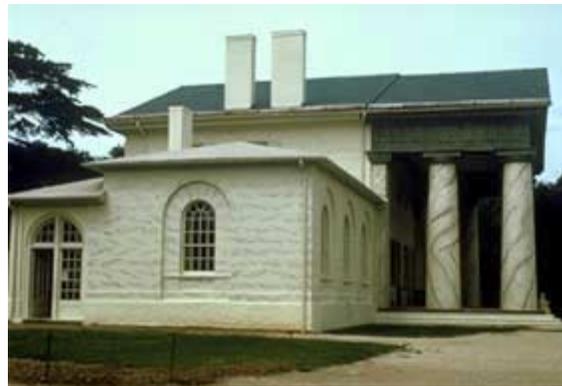
The stucco finish on Arlington House, Arlington, Virginia, was marbled in the 1850s, approximately 30 years after it was built. Photo: NPS files.

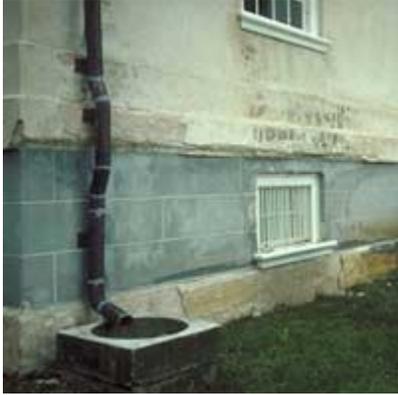
The damage to this stucco appears to be caused by moisture infiltration. Photo: NPS files.

Most stucco deterioration is the result of water infiltration into the building structure, either through the roof, around chimneys, window and door openings, or excessive ground water or moisture penetrating through, or splashing up from the foundation. Potential causes of deterioration include: ground settlement lintel and door frame settlement, inadequate or leaking gutters and downspouts, intrusive vegetation, moisture migration within walls due to interior condensation and humidity, vapor drive problems caused by furnace, bathroom and kitchen vents, and rising damp resulting from excessive ground water and poor drainage around the foundation. Water infiltration will cause wood lath to rot, and metal lath and nails to rust, which eventually will cause stucco to lose its bond and pull away from its substrate.

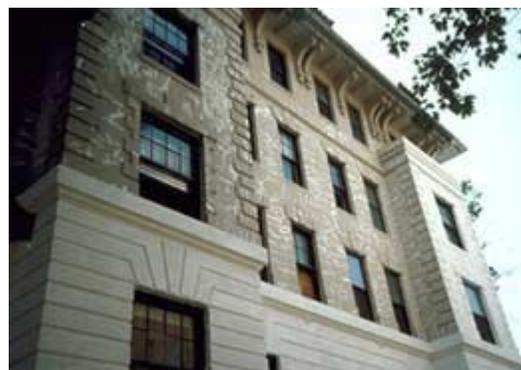
Caulking is not an appropriate method for repairing cracks in historic stucco. Photo: NPS files.

Commercially available caulking compounds are not suitable materials for patching hairline cracks. Because their consistency and texture is unlike that of stucco, they tend

to weather differently, and attract more dirt; as a result, repairs made with caulking compounds may be highly visible, and unsightly. Larger cracks will have to be cut out in preparation for more extensive repair. Most stucco repairs will require the skill and expertise of a professional plasterer.

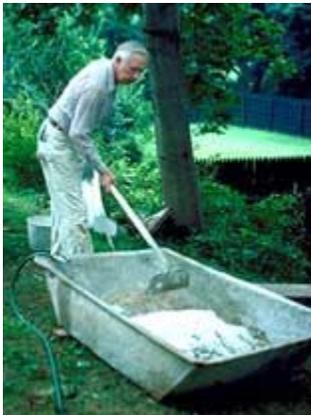
The dry materials must be mixed thoroughly before adding water to make the stucco. Photo: NPS files.

- Stucco mortar should not be over-mixed. (Hand mix for 10-15 minutes after adding water, or machine mix for 3-4 minutes after all ingredients are in mixer.) Over-mixing can cause crazing and discoloration, especially in tinted mortars. Over-mixing will also tend to make the mortar set too fast, which will result in cracking and poor bonding or keying to the lath or masonry substrate.

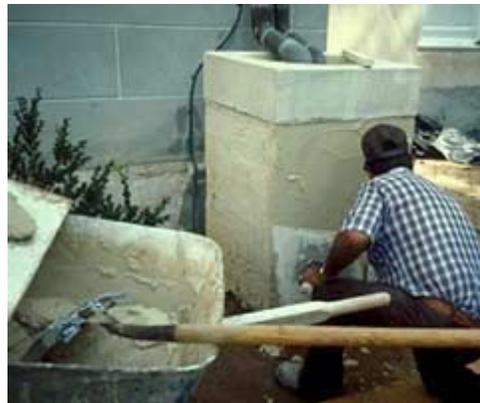
The deteriorated surface of this catch basin is being re-stuccoed. Photo: NPS files.

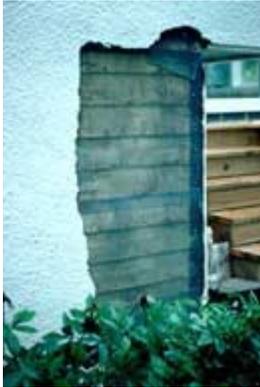
The stucco will be applied to the wire lath laid over the area to be patched. Photo: NPS files.

To ensure a firm bond, the new patch must not overlap the old stucco. If the stucco has lost its bond or key from wood lath, or the lath has deteriorated or come loose from the substrate, a decision must be made whether to try to reattach the old lath, to replace deteriorated lath with new wood lath, or to leave the historic wood lath in place and supplement it with modern expanded metal lath. Unless authenticity is important, it is generally preferable (and easier) to nail new metal lath over the old wood lath to support the patch. Metal lath that is no longer securely fastened to the substrate may be removed and replaced in kind, or left in place, and supplemented with new wire lath.

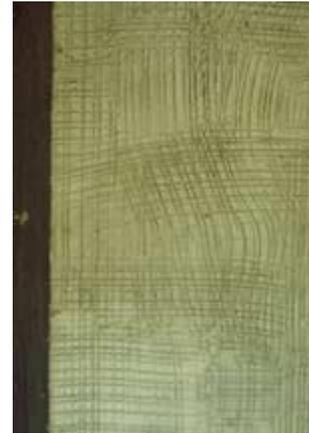
The final finish coat will be applied to this scratch coat.
Photo: NPS files.

After thoroughly dampening the masonry or wood lath, the first, scratch coat should be applied to the masonry substrate, or wood or metal lath, in a thickness that corresponds to the original if extant, or generally about 1/4" to 3/8". The scratch coat should be scratched or crosshatched with a comb to provide a key to hold the second coat. It usually takes 24-72 hours, and longer in cold weather, for each coat to dry before the next coat can be applied. The second coat should be about the same thickness as the first, and the total thickness of the first two coats should generally not exceed about 5/8". This second or leveling coat should be roughened using a wood float with a nail protruding to provide a key for the final or finish coat. The finish coat, about 1/4" thick, is applied after the previous coat has initially set. If this is not feasible, the base coat should be thoroughly dampened when the finish coat is applied later. The finish coat should be worked to match the texture of the original stucco.

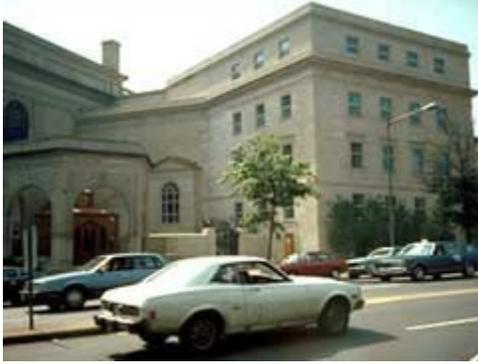
The new addition on the right is stucco scored to imitate the limestone of the historic building on the left. Photo: NPS files.

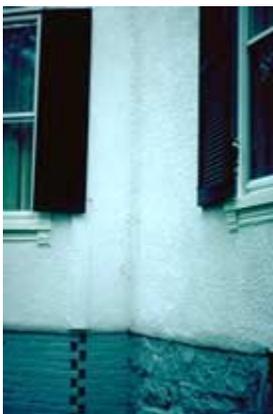
This stucco house has a rough cast finish. Photo: NPS files.

The most common early-twentieth century stucco finishes are often found on bungalow-style houses, and include: spatter or spatterdash (sometimes called roughcast, harling, or wetdash), and pebble-dash or drydash. The spatterdash finish is applied by throwing the stucco mortar against the wall using a whisk broom or a stiff fiber brush, and it requires considerable skill on the part of the plasterer to achieve a consistently rough wall surface. The mortar used to obtain this texture is usually composed simply of a regular sand, lime, and cement mortar, although it may sometimes contain small
