**GRAYMONT**

## Rehabilitation Management Plan (RMP)

Sulcor Limestone Mine

Date  
13 March 2024

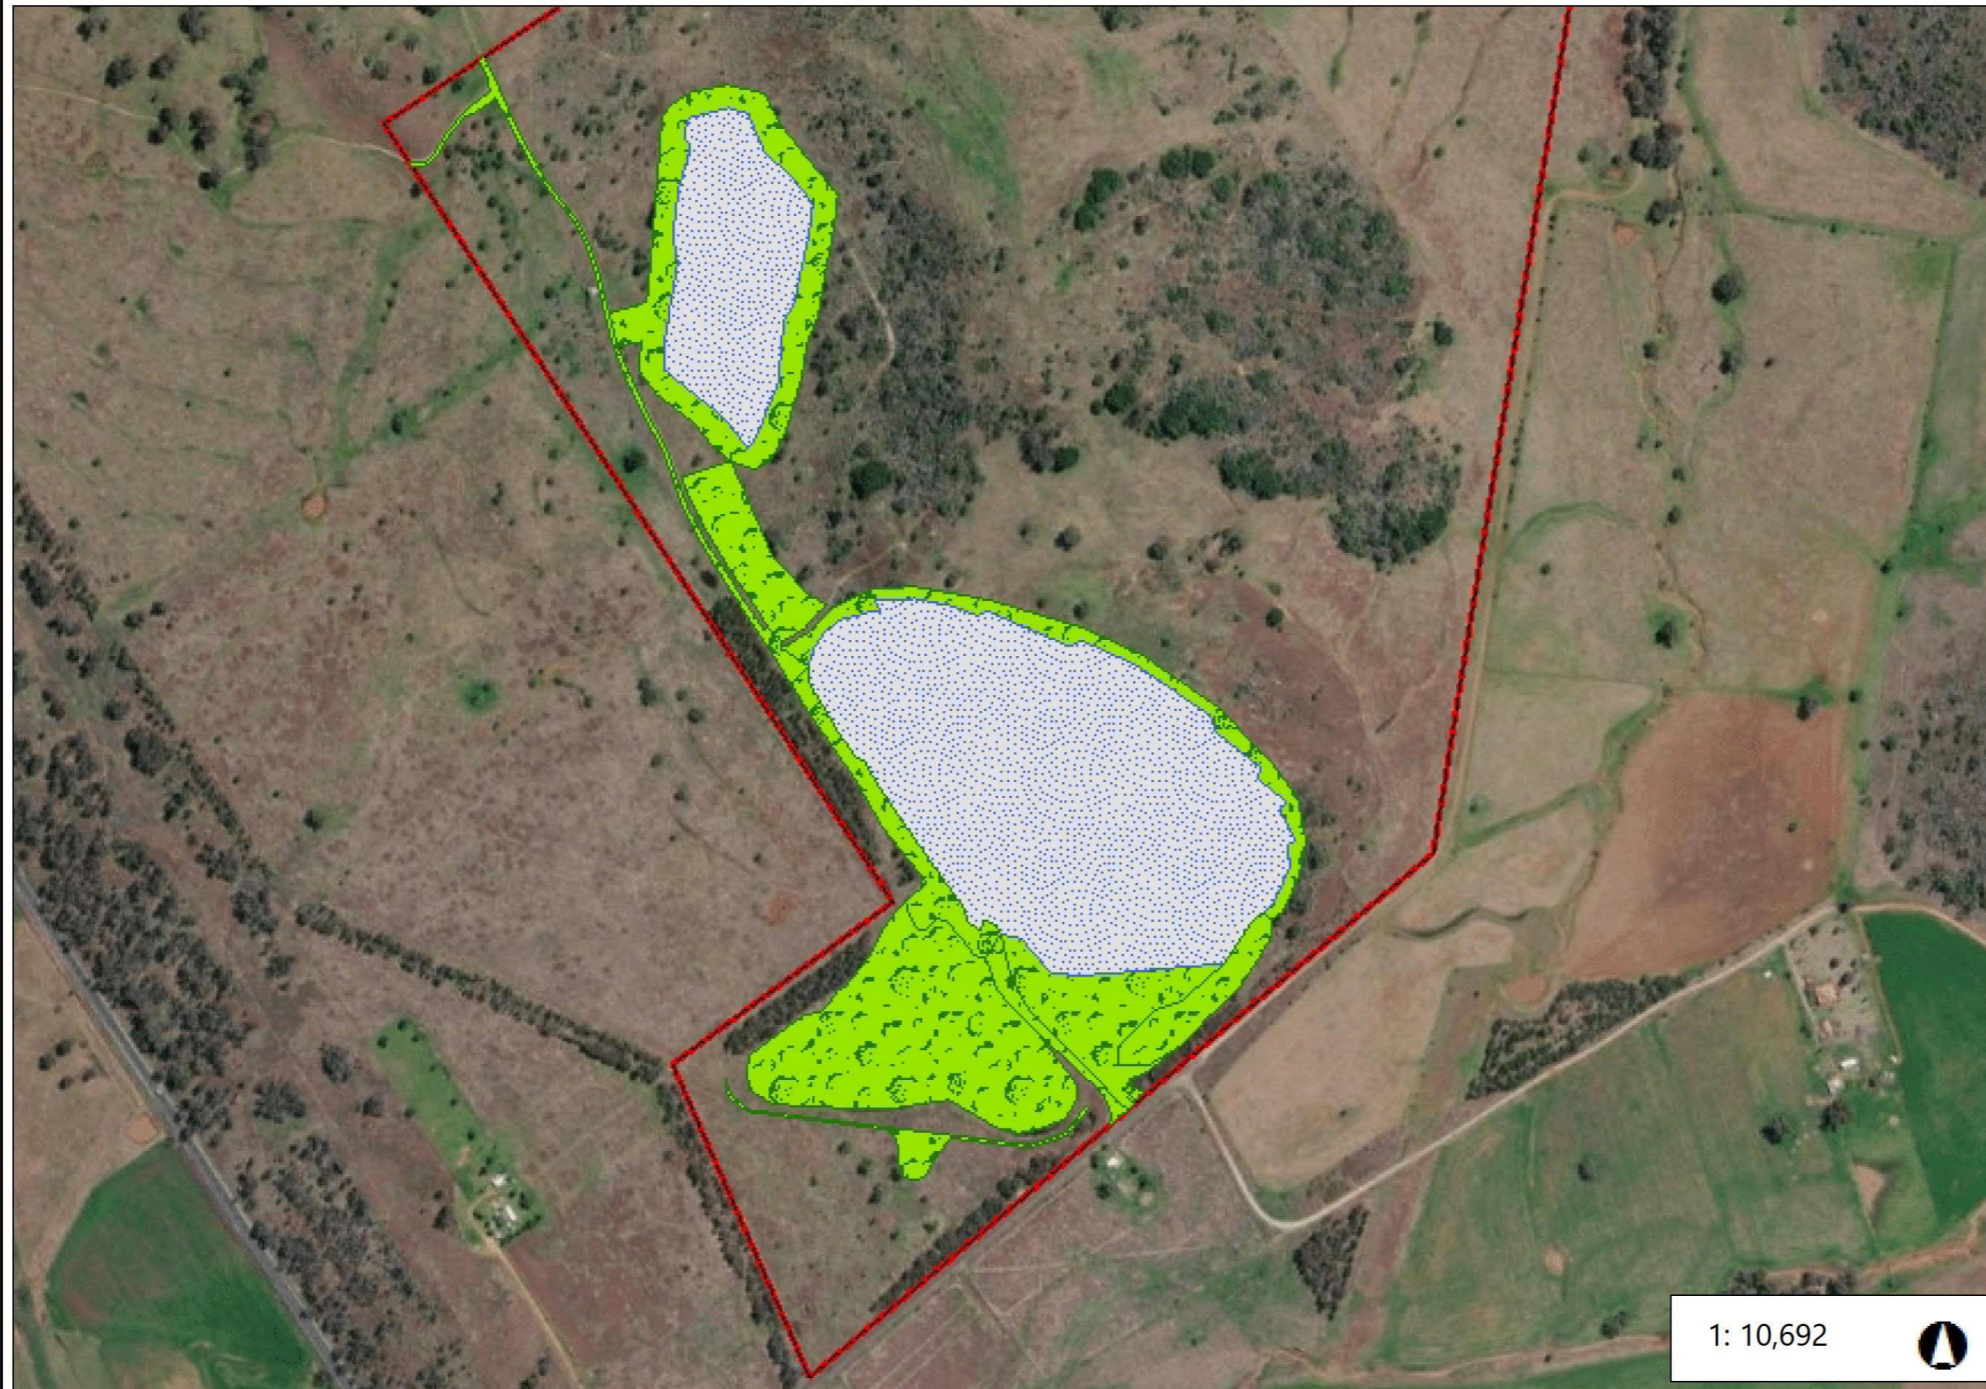
Figure 2: Final landform and rehabilitation plan - Final land use

# Sulcor Limestone Mine Plan 1A: Final Land Use

Year 2045

The Final Landform and Rehabilitation Plan was approved by the Secretary on 12 December 2023 (reference FLRP0001261). Figures Figure 2 to Figure 5 provide copies of the approved final landform and rehabilitation plans submitted to the mine rehabilitation portal. Specifically, these Figures depict:

- Final Land Use (Figure 2)
- Final Landform Features (Figure 3)
- Current Authorisations (Figure 4)
- Final Landform Contours (Figure 5).

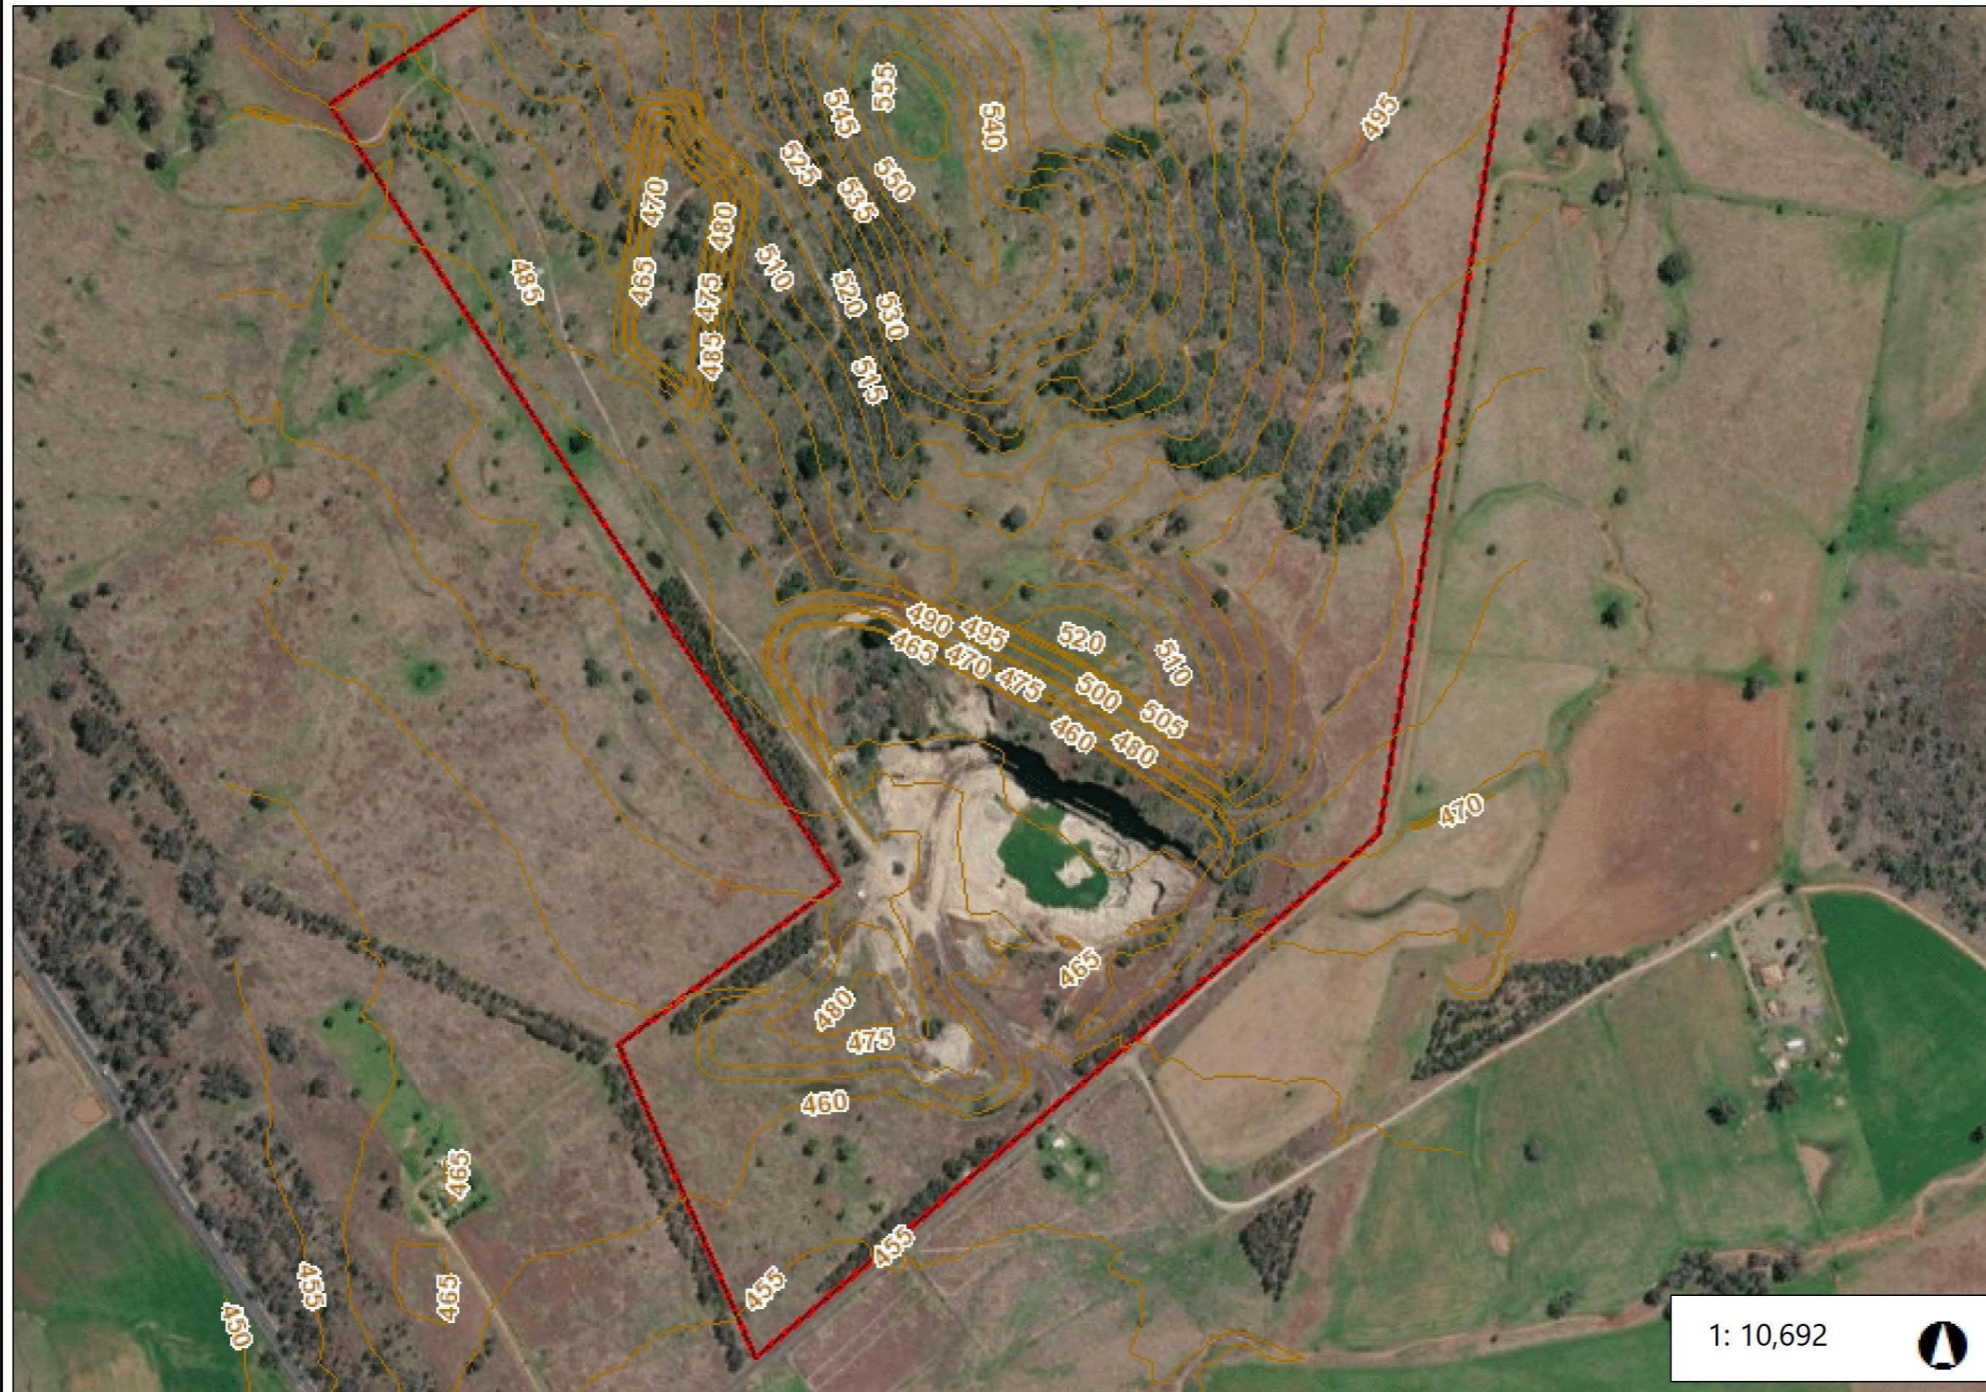
Figure 5: Final landform and rehabilitation plan - Final landform contours

# Sulcor Limestone Mine Plan 2A: Final Landform Contours

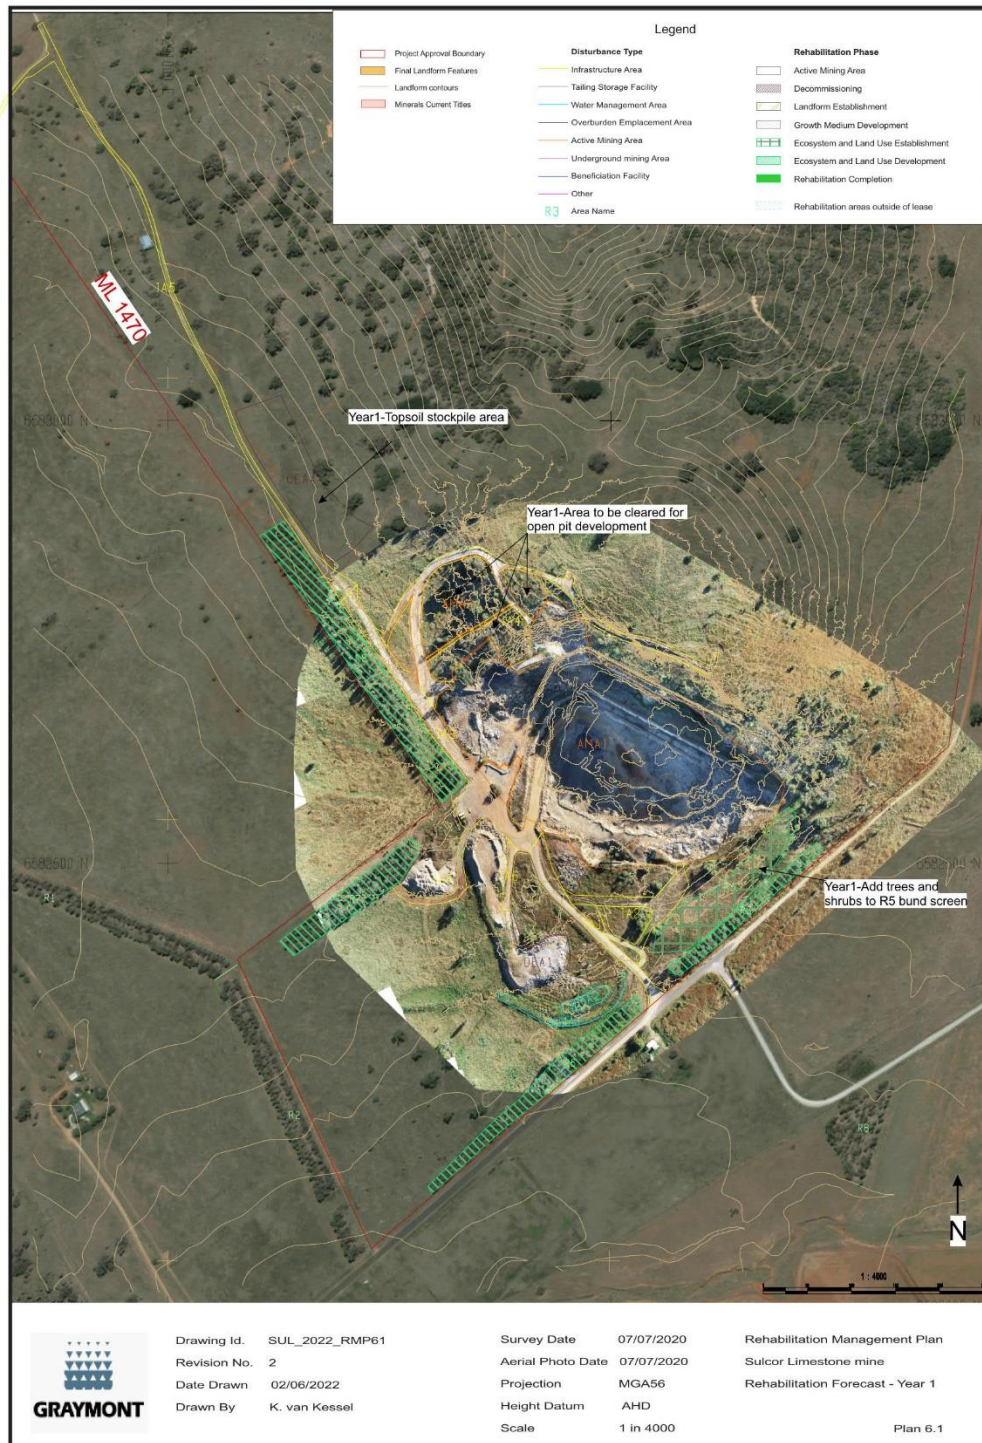
Figure 6: Rehabilitation by the end of 2022

Figure 6 shows that the rehabilitation plans for the year include no expansion of existing rehabilitation sites and no commencing of rehabilitation for mining disturbed areas. Maintenance will be performed on rehabilitation area internally identified as R5, to improve vegetation uptake. This will include sowing of new vegetation and any measures needed for soil health that are deemed necessary.

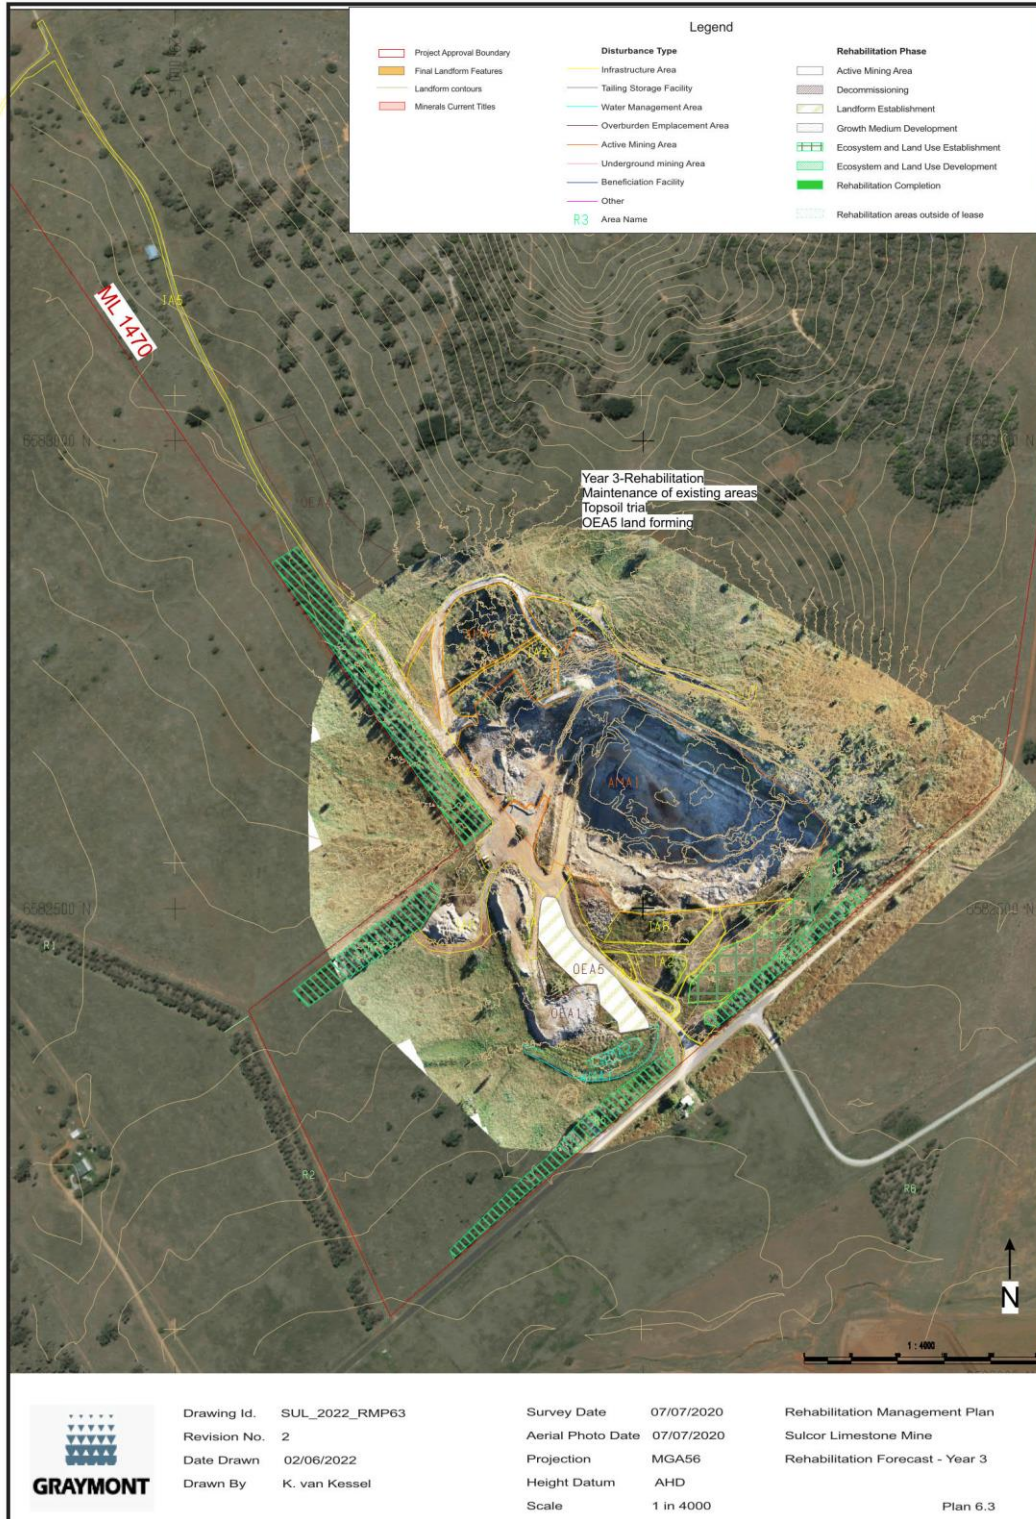
Figure 8: Rehabilitation by the end of 2024

Figure 8 shows the rehabilitation plans for 2024. This includes the commencement of the landform establishment phase for the overburden emplacement area OEA5.

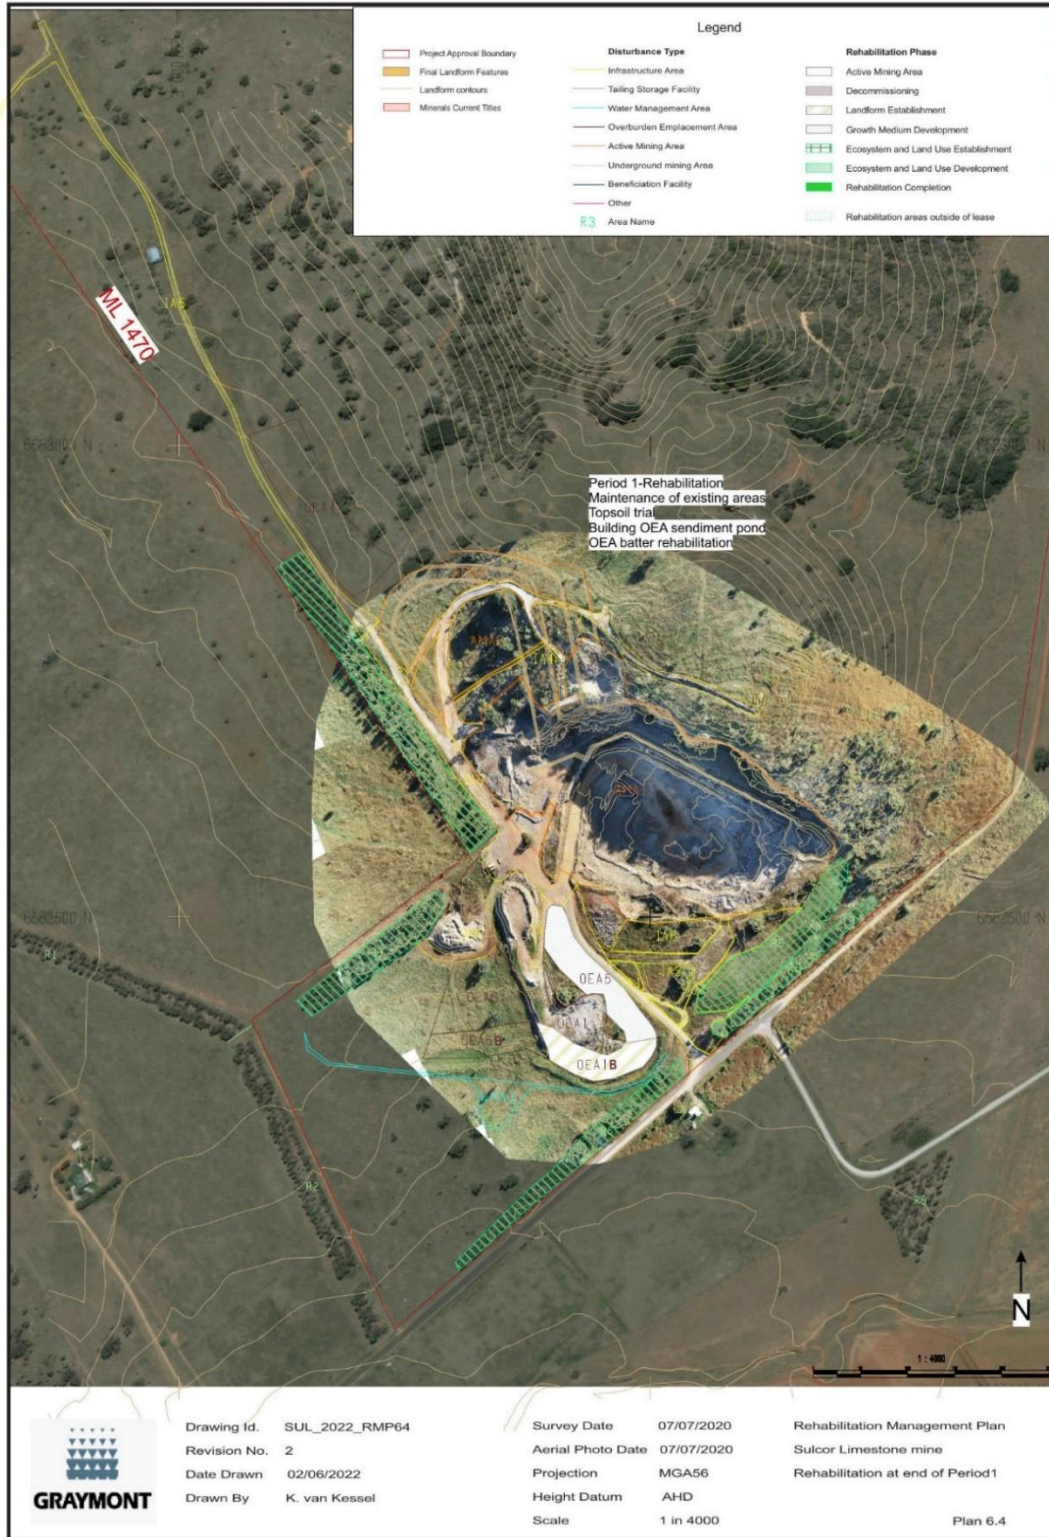
Figure 9: Rehabilitation by the end of 2027

Figure 9 shows the proposed rehabilitation activities to be completed by 2027. Overburden emplacement areas OEA1B and OEA5 will be in the landform establishment and growth medium development phases, respectively.

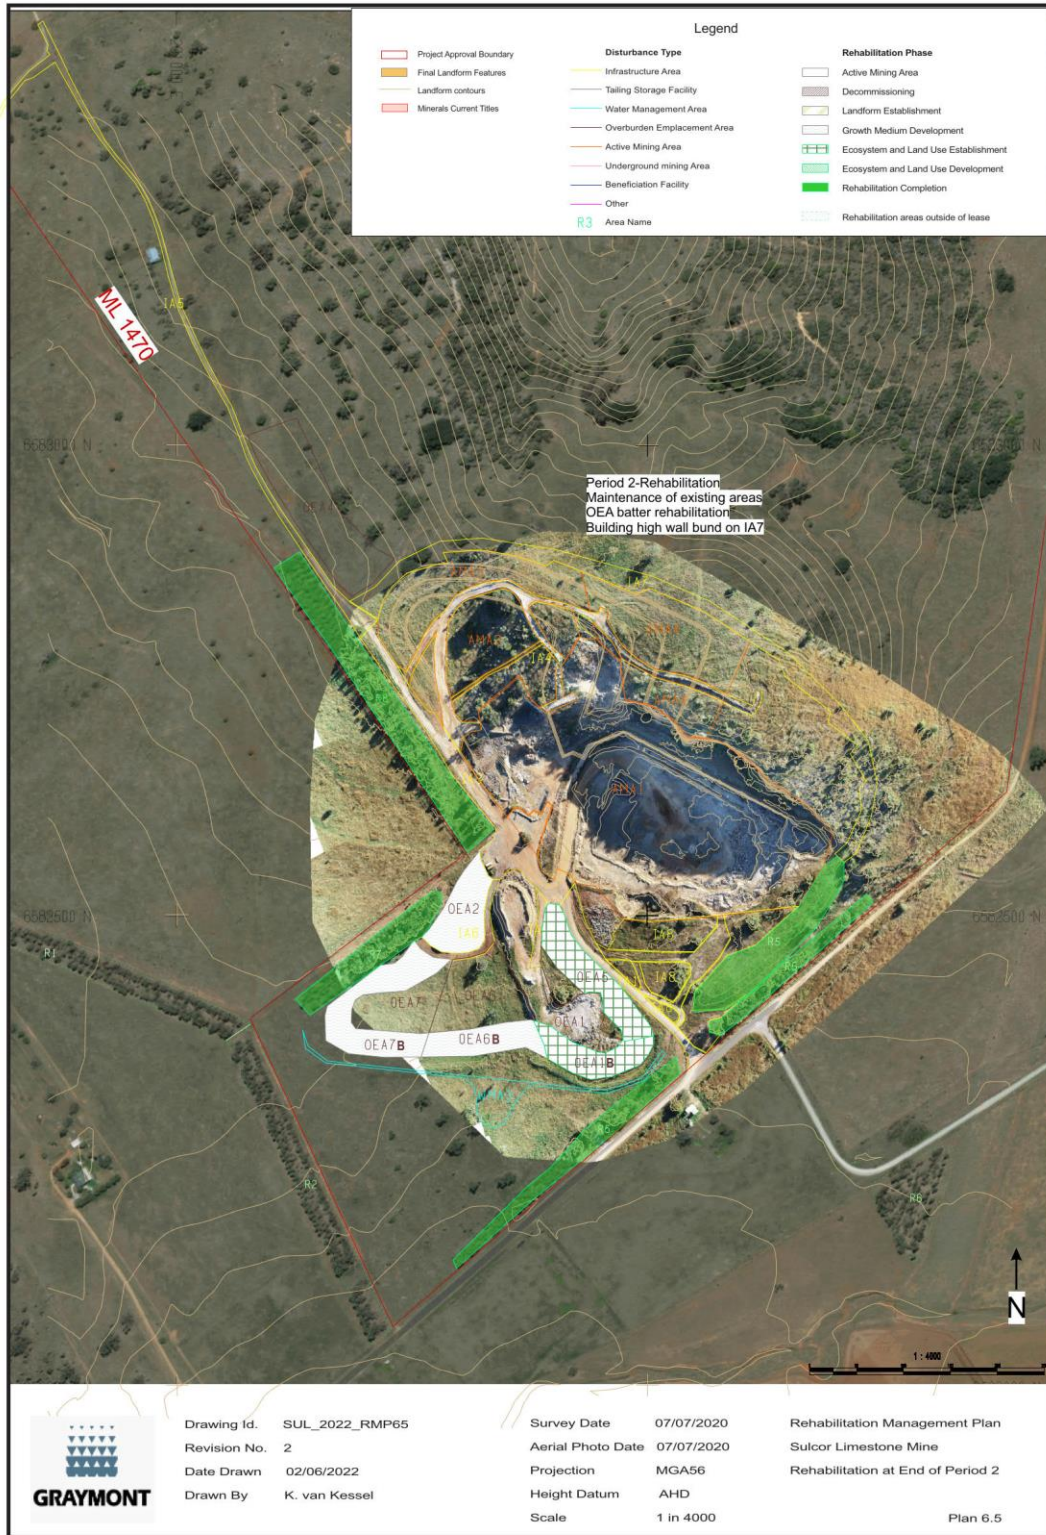
Figure 10: Rehabilitation by the end of 2032

Figure 10 shows the proposed rehabilitation activities to be completed by 2032. OEA1B and OEA5 are expected to be in the ecosystem and land use establishment phase. OEA2, OEA6B and OEA7B are intended to be in the growth medium development stage.

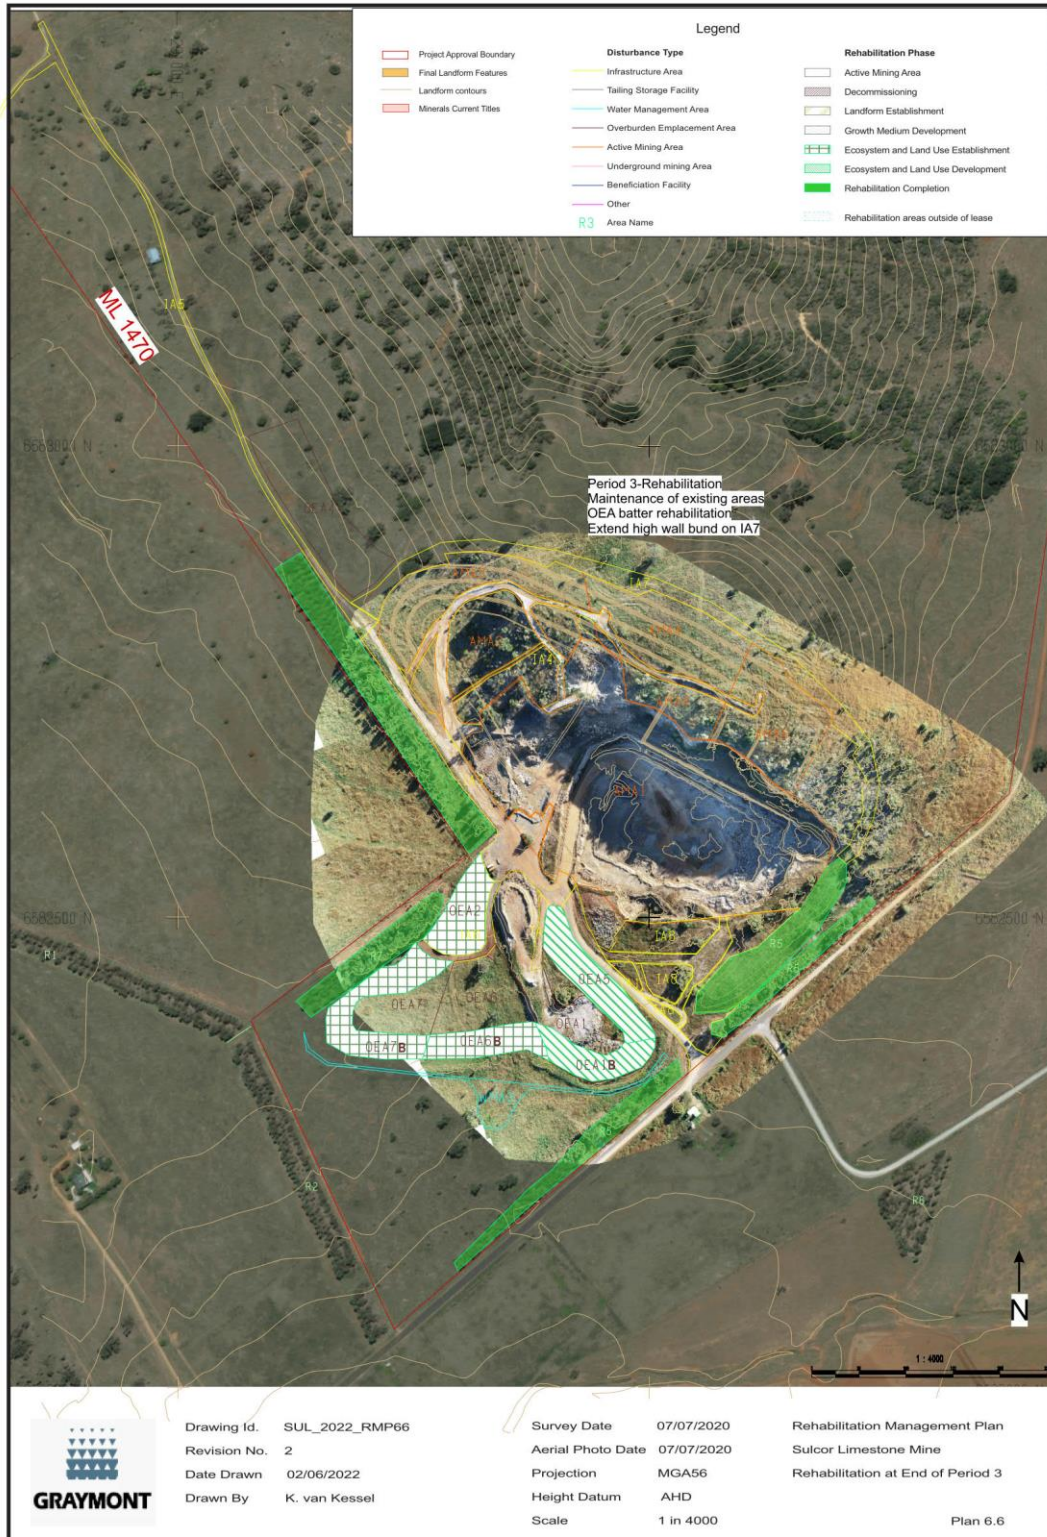
Figure 11: Rehabilitation by the end of 2037

Figure 11 shows the proposed rehabilitation activities to be completed by 2037. OEA1B and OEA5 are expected to be in the ecosystem and land use development phase. OEA2, OEA6B and OEA7B are expected to be in the ecosystem and land use establishment stage.

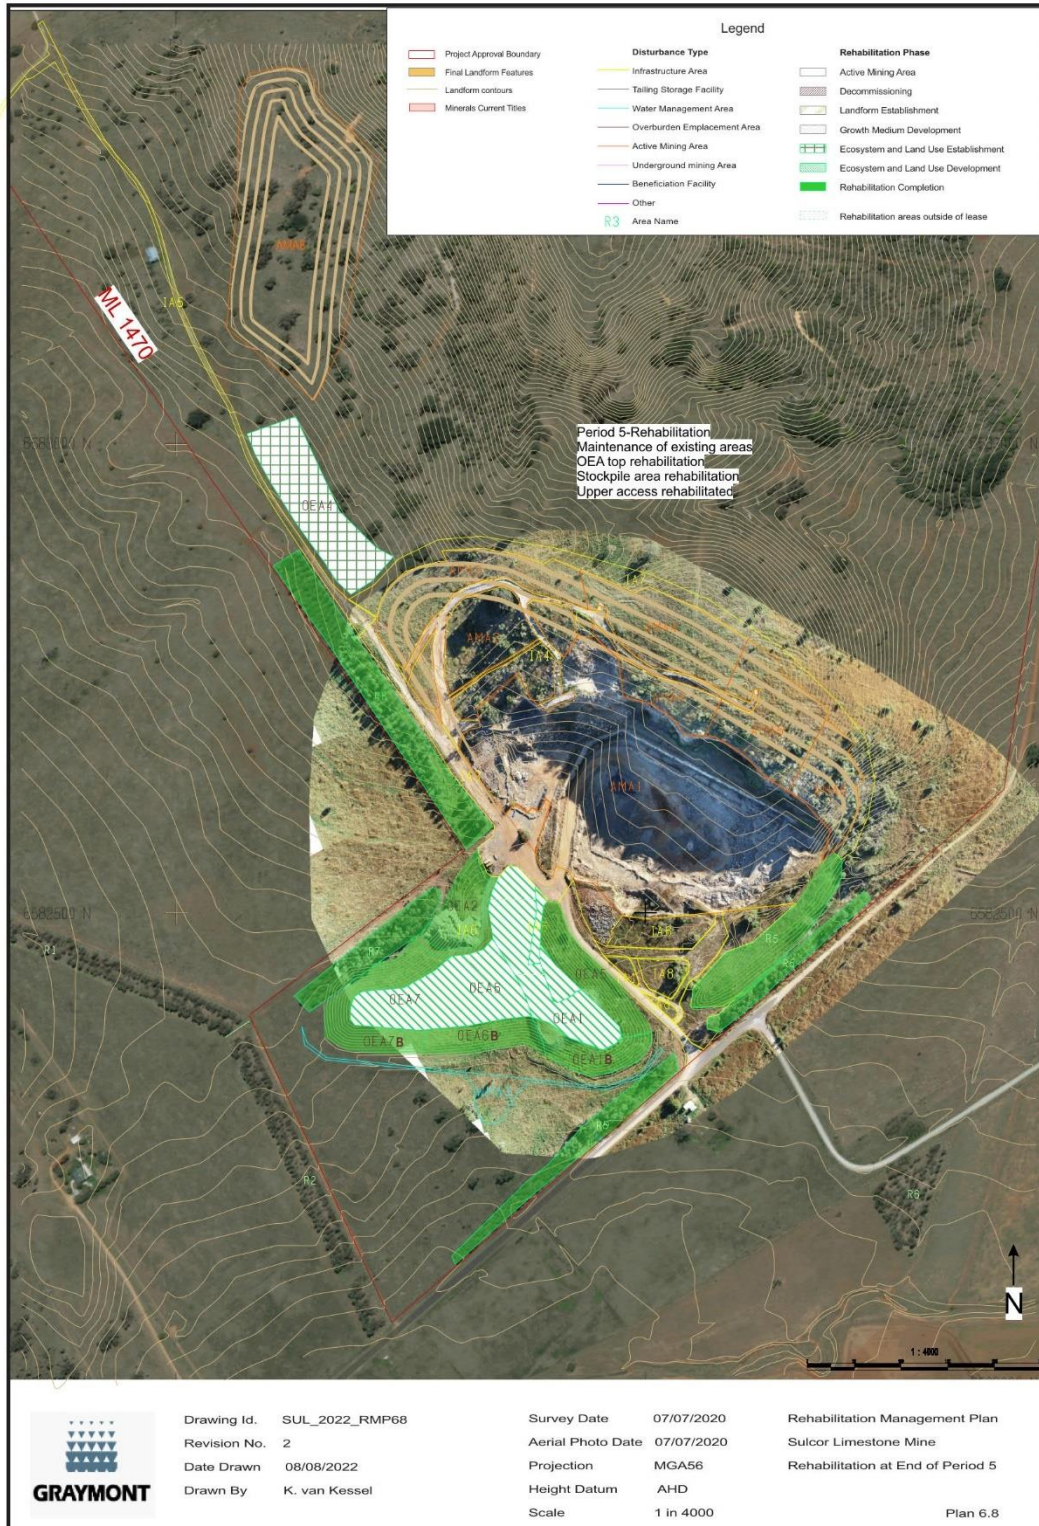
Figure 12: Rehabilitation by the end of 2042

Figure 12 shows the proposed rehabilitation activities to be completed by 2042. Overburden emplacement areas OEA1, OEA6 and OEA7 will be intended to be in the ecosystem and land use development phase, while OEA4 is intended to be in the ecosystem and land use establishment phase.

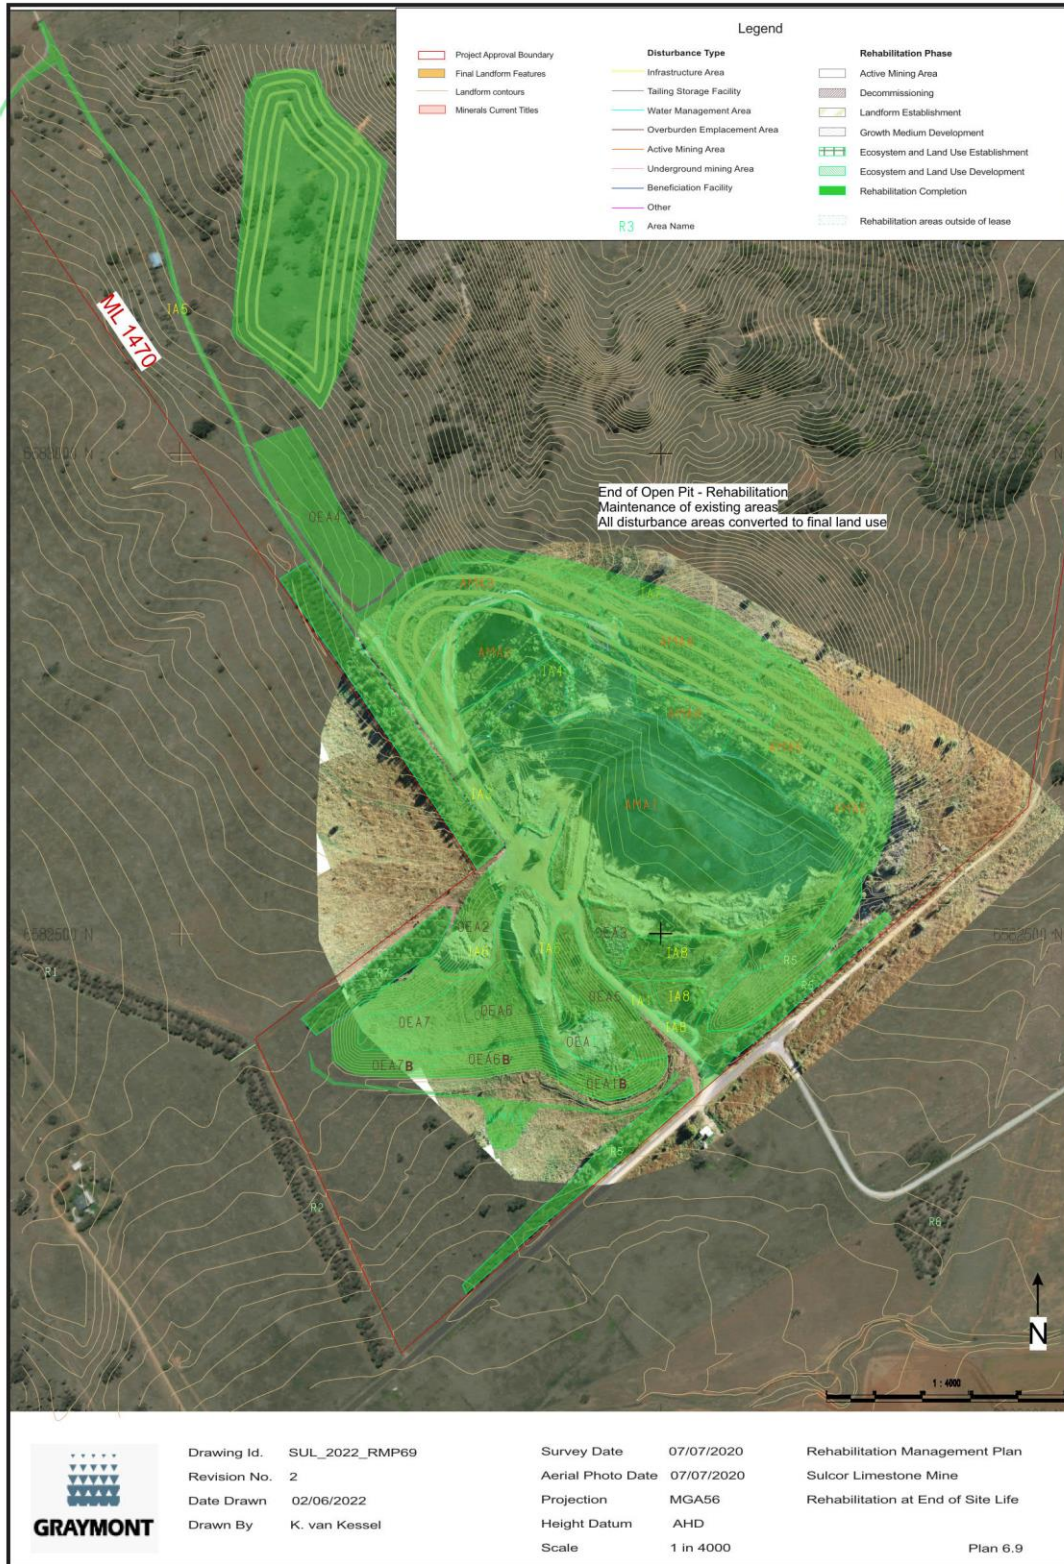
Figure 13: End of life rehabilitation by 2045

Figure 13 presents the rehabilitation schedule to be completed by the end of the year 2045. All disturbed areas are expected to be completed rehabilitated by this time.

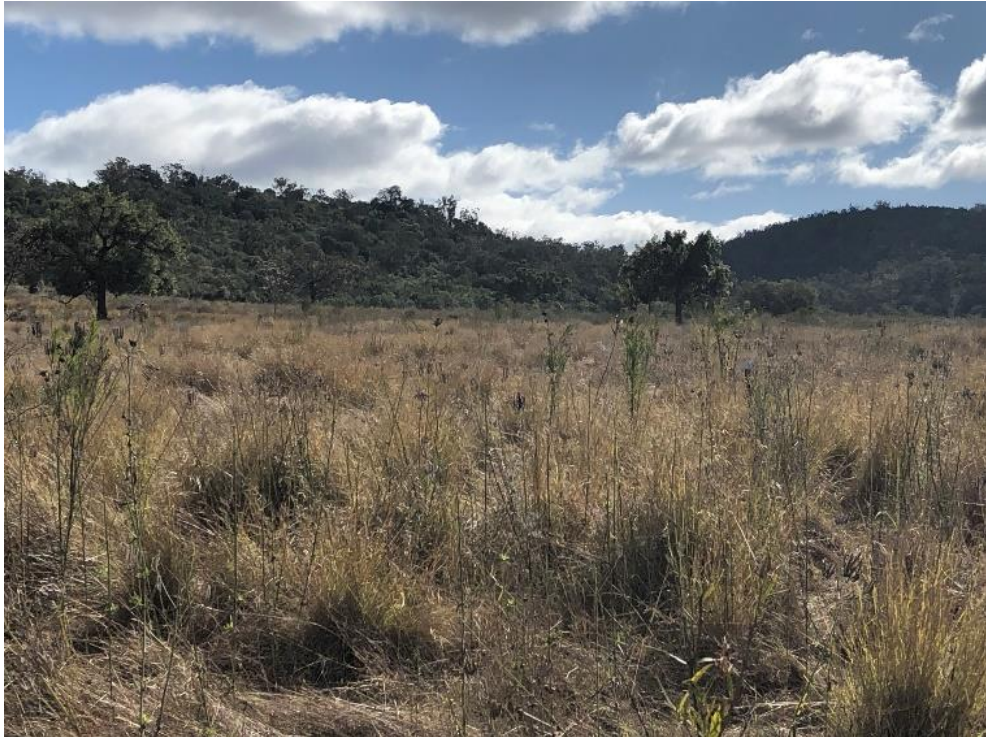
Table 13: Analogue site 1

<b>Coordinates</b>	56 J 0291906 : 6583329
<b>Ecosystem Type</b>	Grassy Woodland
<b>Canopy / Emergent</b>	Open Woodland (<10% tree cover). Native species such as White Box ( <i>Eucalyptus aldens</i> ) Black Cypress Pine ( <i>Callitris endlicheri</i> ), Silver-leaved Ironbark ( <i>Eucalyptus melanophloia</i> ) and Kurrajong ( <i>Brachychiton populneus</i> ) mixed with introduced species such as Peppercorn Trees ( <i>Schinus mole</i> )
<b>Shrub / Understory Layer</b>	Minimal native shrub layer. Primarily tall introduced species such as fleabane and vervain. These are considered weeds within pasture lands and should be controlled as part of the weed management program.
<b>Ground / Herb Layer</b>	100% covered with mixed native and introduced species, consistent with grazing pastoral land. Species not defined.
<b>Fallen timber (Coarse woody debris)</b>	Very low – Occasional thin (5-10mm diameter) sticks and rare medium (10-50mm diameter) sticks

<b>Landform</b>	Very gentle slopes, often less than 5%. Steeper slopes toward the base of the hill where tree density increases, between 5% and 15%. Undulating hills and long convex to simple side slopes.
<b>Soil Conditions</b>	Soils were not surveyed

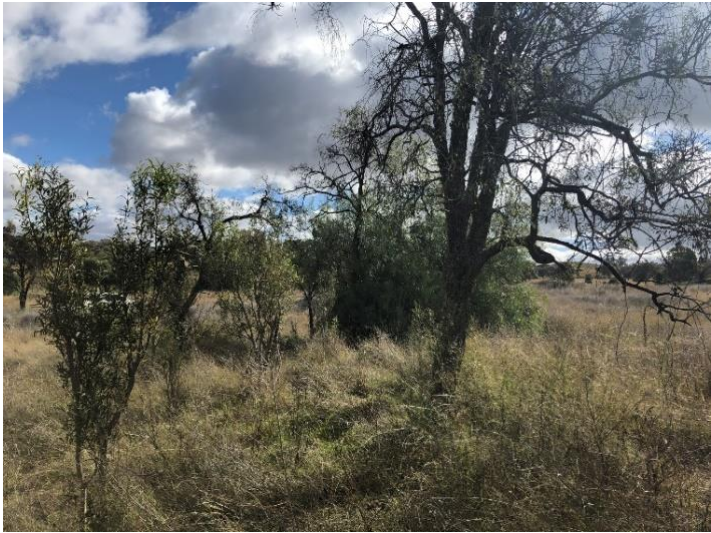
Table 14: Analogue site 2

<b>Coordinates</b>	56 J 0290901 : 6583406
<b>Ecosystem Type</b>	Woodland
<b>Canopy / Emergent</b>	Woodland (10-30%) cover. Native species such as White Box ( <i>Eucalyptus aldens</i> ), Yellow Box ( <i>Eucalyptus melliodora</i> ) Black Cypress Pine ( <i>Callitris endlicheri</i> ), Silver-leaved Ironbark ( <i>Eucalyptus melanophloia</i> ), numerous wattles ( <i>Acacia sp.</i> ) and Rough-barked apple ( <i>Angophora floribunda</i> ) mixed with introduced species such as Peppercorn Trees ( <i>Schinus molle</i> ). Canopy cover tended to be clustered close together except for larger gum trees and Angophora.
<b>Shrub / Understory Layer</b>	Sparse shrub layer mainly in rocky areas. Includes Sticky Hop-bush ( <i>Dodonaea viscosa subsp. Angustifolia</i> ), Native olive ( <i>Notolea microcarpa</i> ) and African Boxthorn ( <i>Lycium ferocissimum</i> ).

<b>Ground / Herb Layer</b>	Ground layer heavily weed impacted with Milk Thistle ( <i>Silybum marianum</i> ) and Fleabane ( <i>Conyza subsp. speciosa</i> ). Introduced Coolatai grass is widespread. Some native tussock grasses and forbs persist in small patches. 5-10% rocky ground cover with limestone.
<b>Fallen timber (Coarse woody debris)</b>	Common – Small, medium, and large sticks, with some large logs / fallen branches
<b>Landform</b>	Gentle slopes between 5 and 10%. Small sections of exposed limestone outcroppings. Higher slopes transition towards 20°, with an increase in tree density. Slope at site is listed as 5%.
<b>Soil Conditions</b>	Soils were not surveyed
